CRS No. N05202

Name: House, Road 420

CULTURAL RESOURCE SURVEY
SURVEY UPDATE FORM

DELAWARE STATE HISTORIC PRESERVATION OFFICE
15 THE GREEN, DOVER, DE 19901

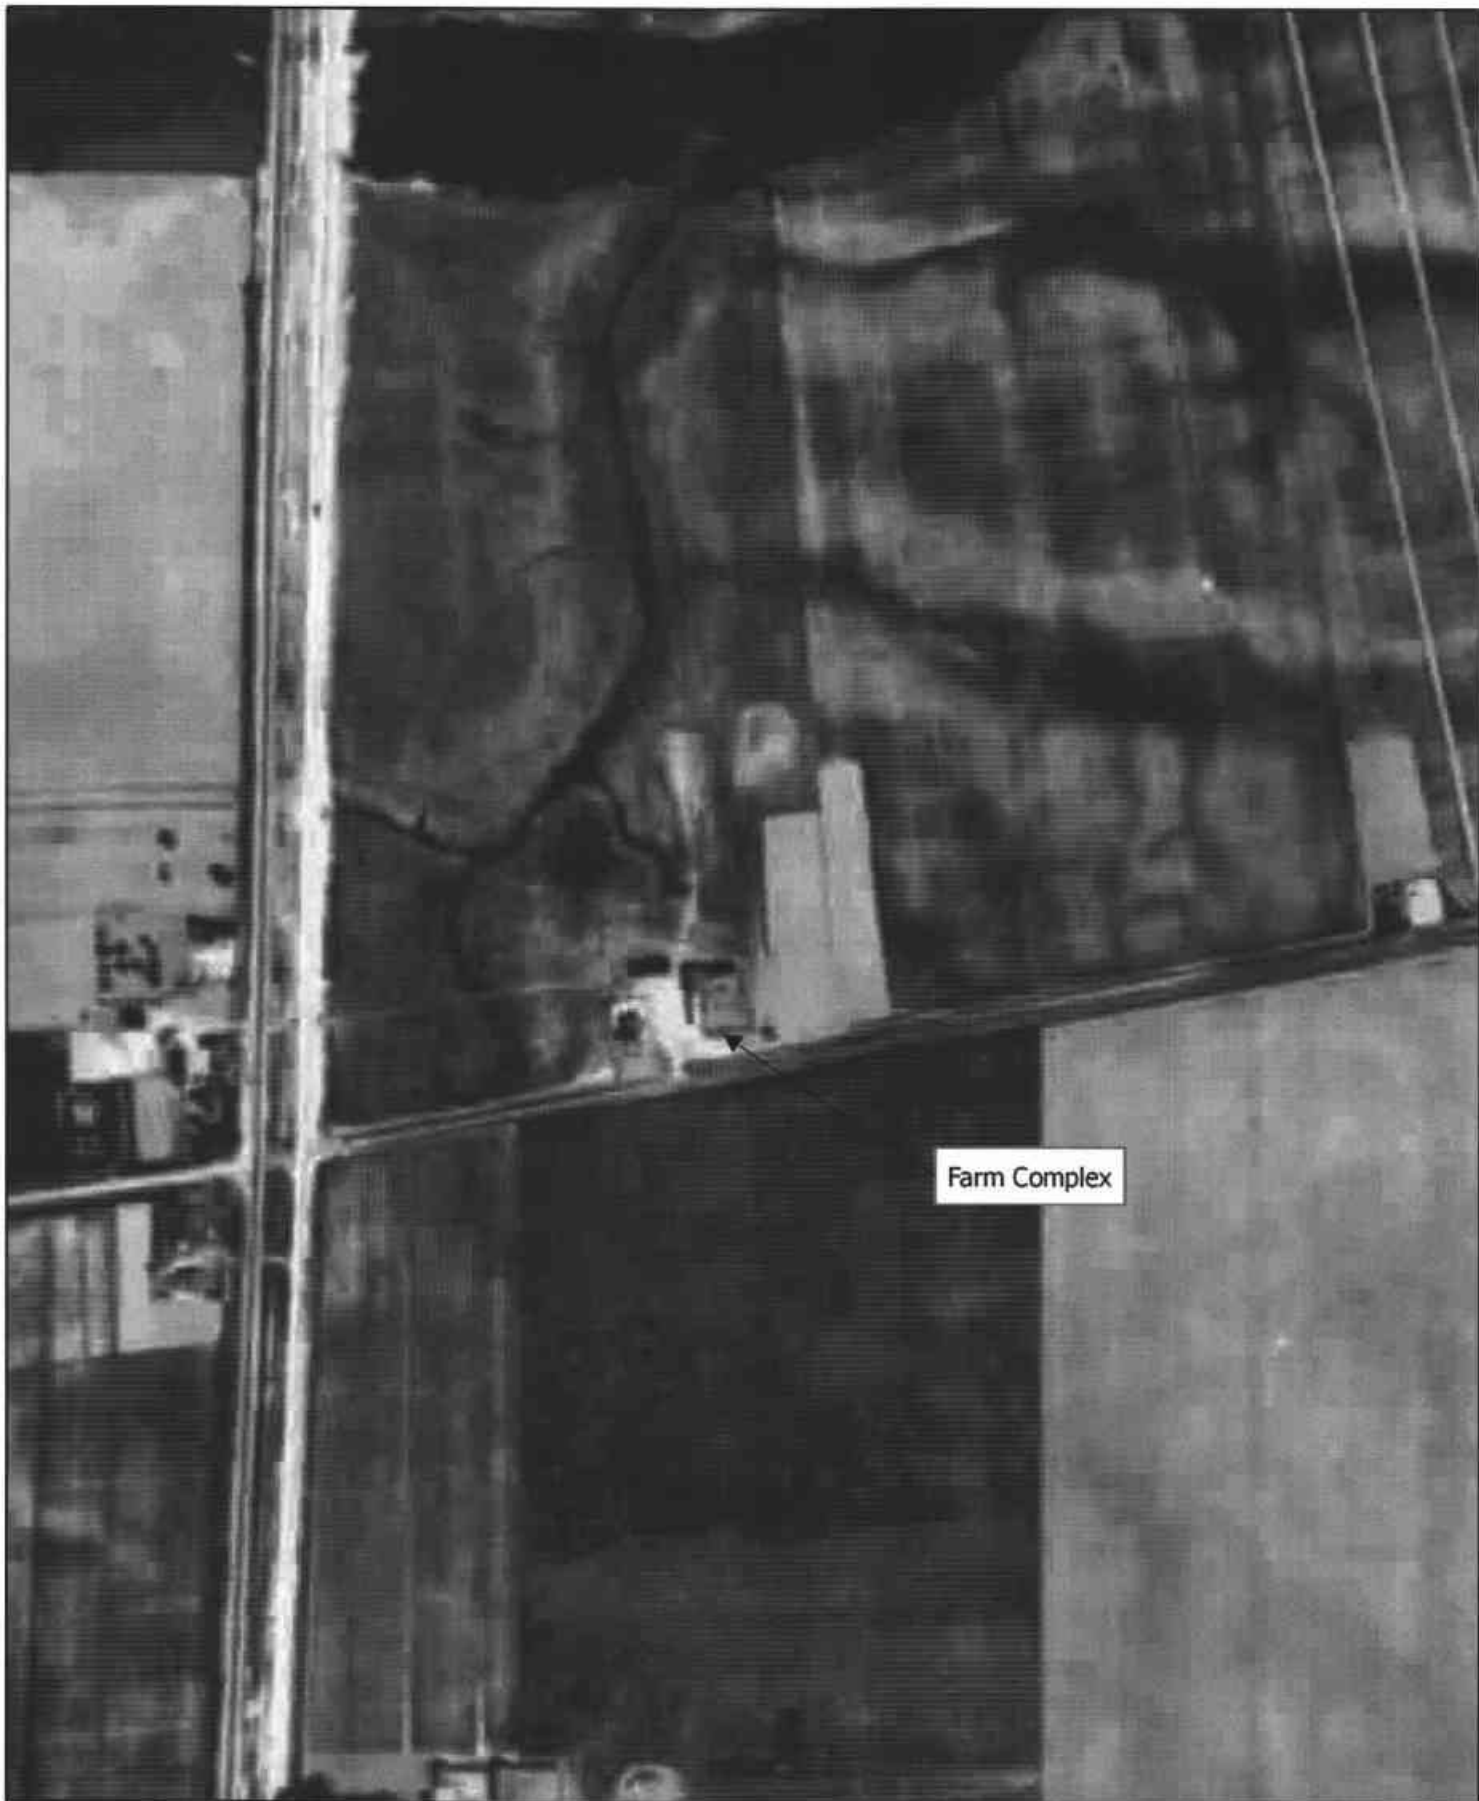
U.S. 301 Project Development
1932 Aerial

Farm Complex

House, Road 420 - CRS No. N05202

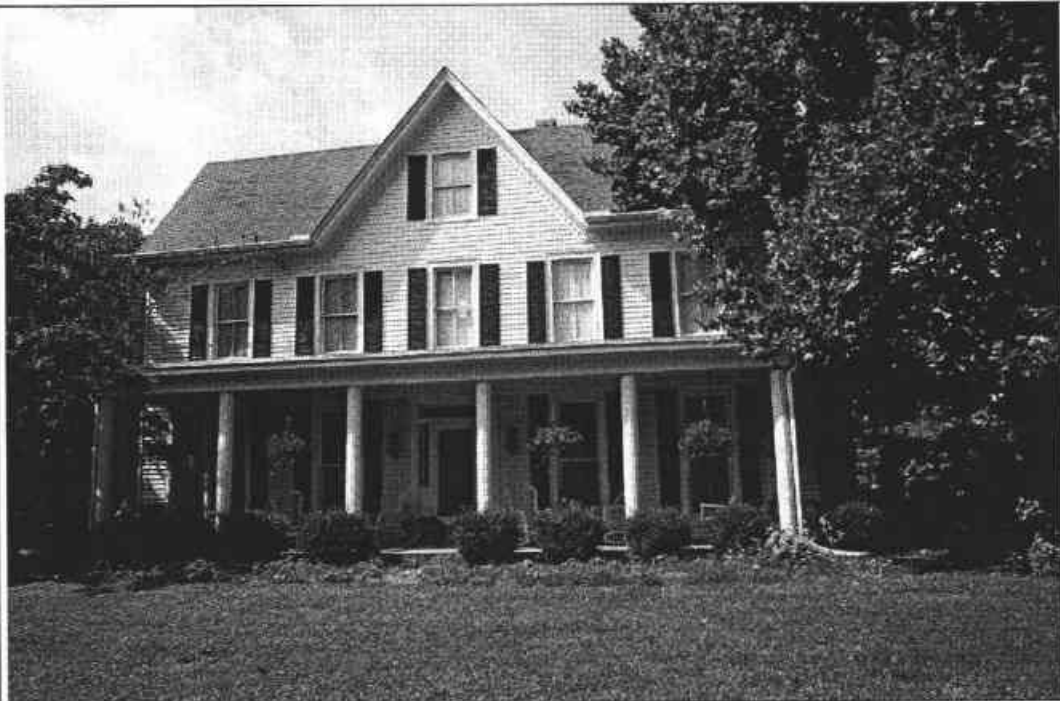
N05208. Photograph 1: Dwelling, south elevation, view to north.

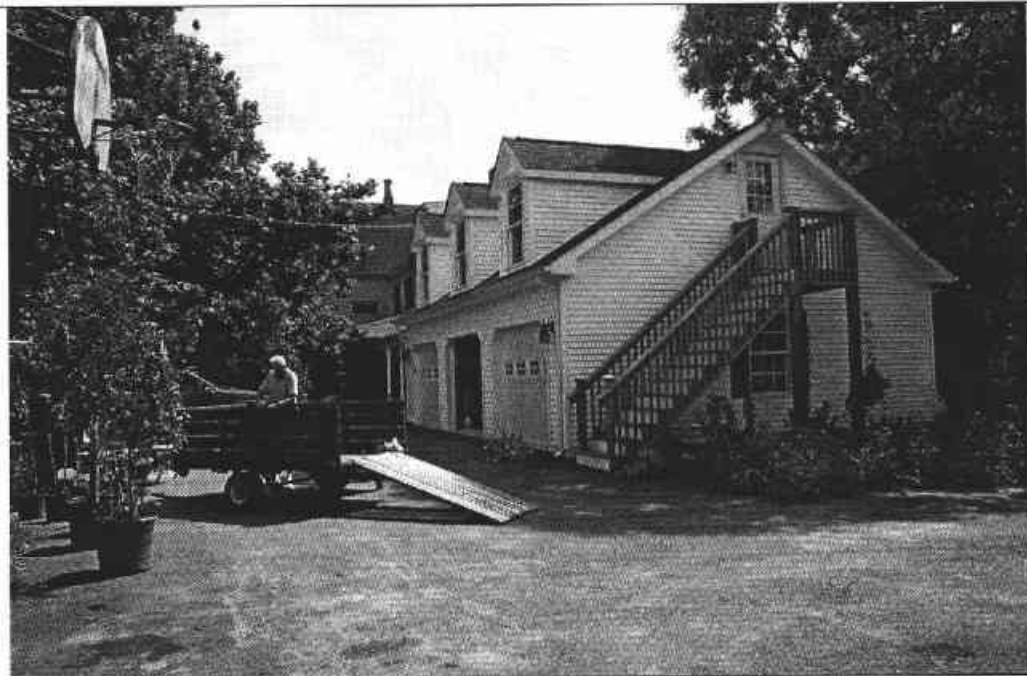
N05208. Photograph 2: Dwelling, north and east elevations, view to southwest. Note modern garage and garage-apartment additions

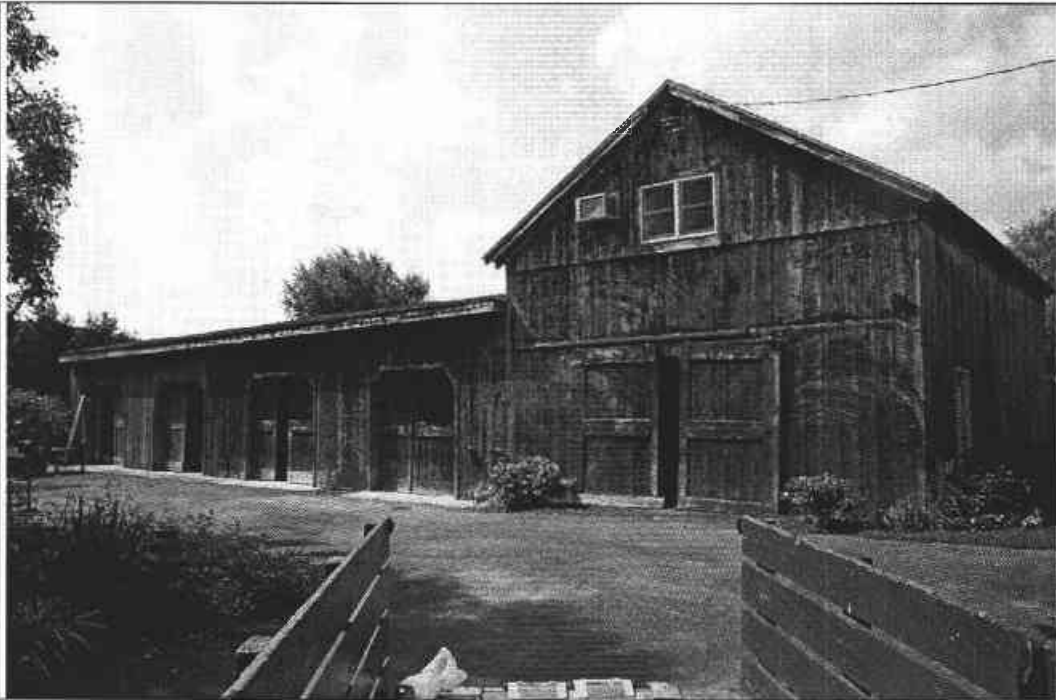
N05208. Photograph 3: Former corn crib/grain barn with modern garage bay additions, south and east elevations, view to northwest.

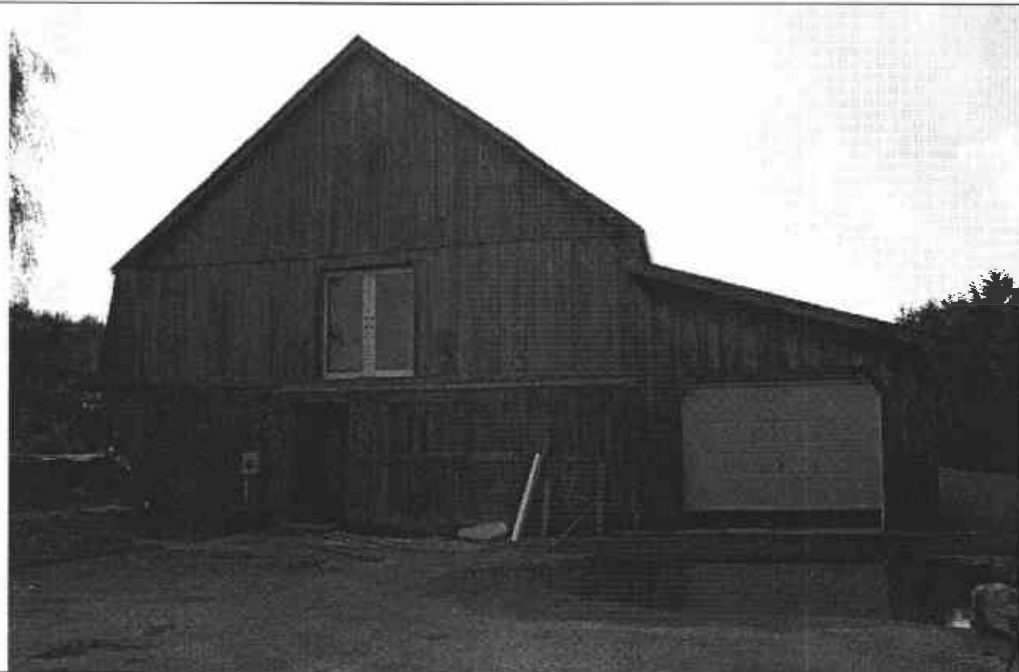
N05208. Photograph 4: Former cow barn (old dairy barn), east elevation, view to west. Note modern garage door and modern windows.

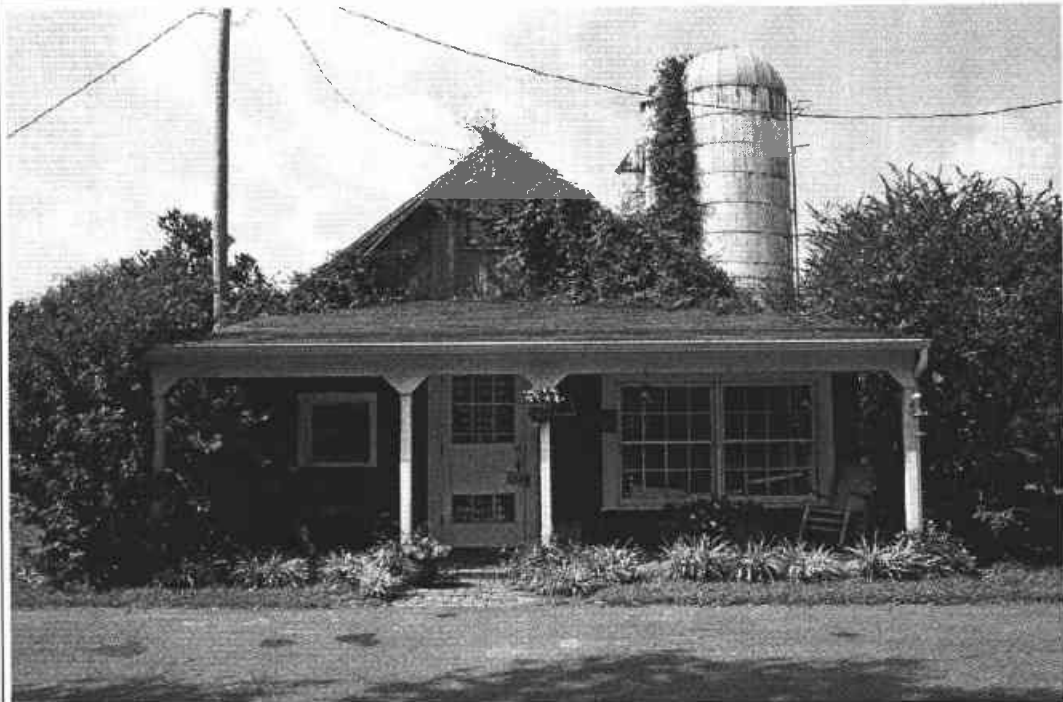
N05208. Photograph 5: Former dairy house/dairy barn, now converted to an antique shop, south elevation, view to north.

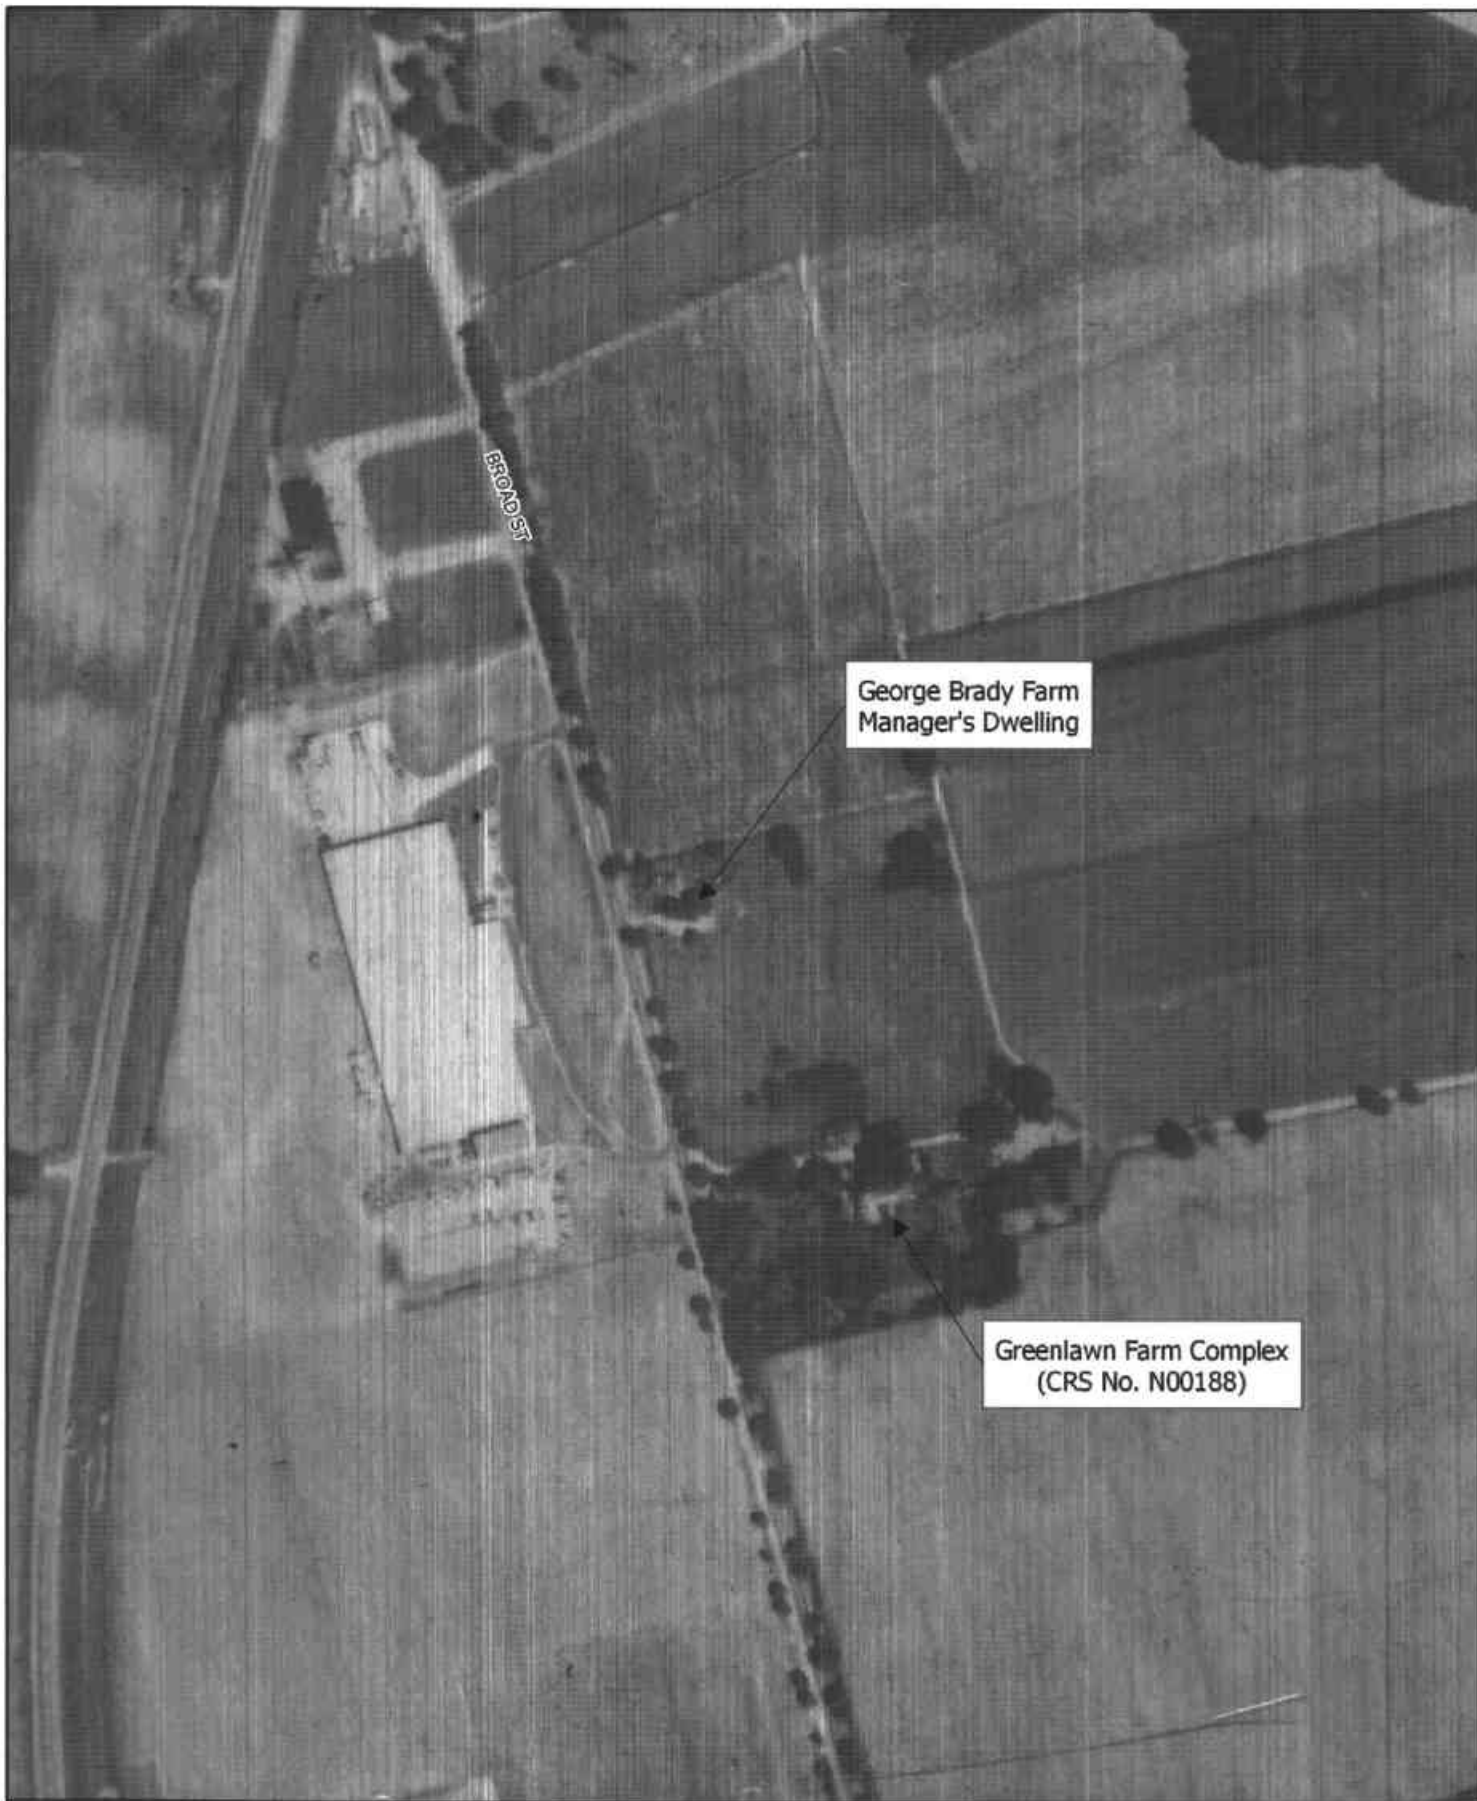
U.S. 301 Project Development
1962 Aerial
George Brady Farm Manager's Dwelling - CRS No. N05216

This property was documented in 1992 by the DESHPO, prior to the building's removal to Brook Ramble (CRS No. N00101). As part of the current study, a CRS 10 Survey Update Form was prepared. Due to ground disturbance in the location of the former dwelling, the potential for an intact archaeological site may have been compromised. However, should the U.S. 301 project have the potential to directly impact this location, it should be examined for archeological potential to confirm presence or absence of a site.

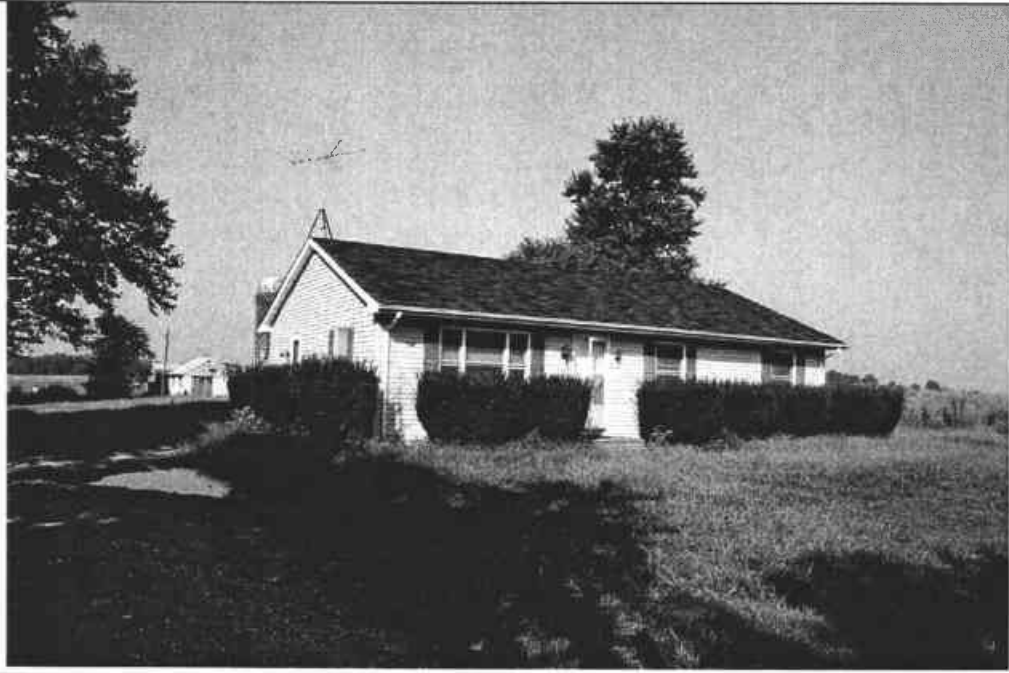
N05218. Photograph 1: Dwelling, east and south elevations, view looking northwest. This is the modern ranch style dwelling located in approximately the same place as the original farmhouse.

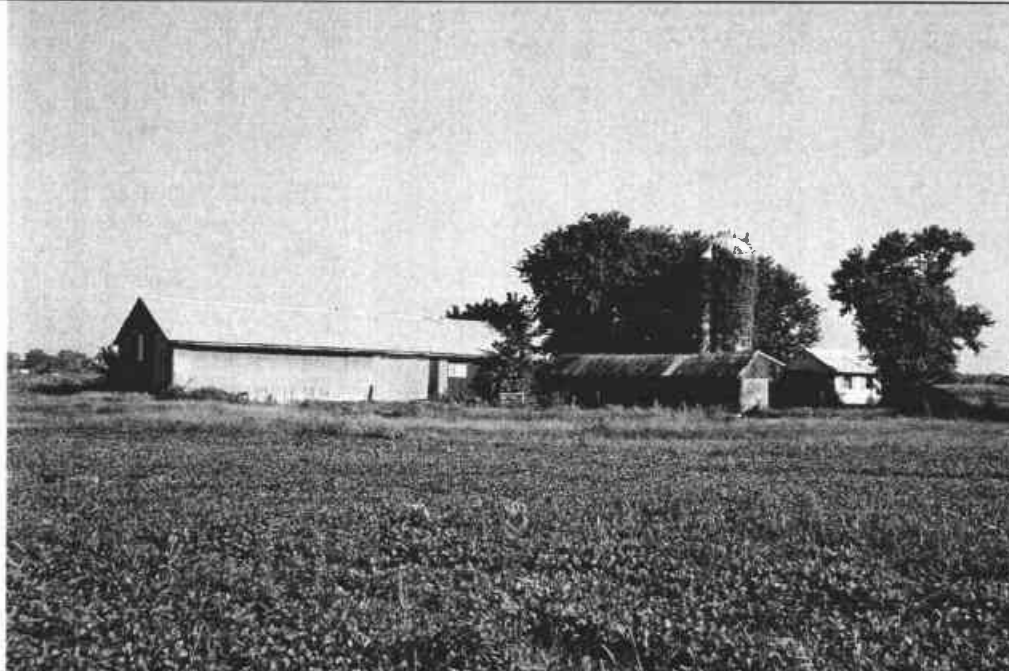
N05218. Photograph 2: Farm Complex, view looking northeast. This photo shows the original farm complex that is no longer in use. A number of smaller outbuildings have been razed.

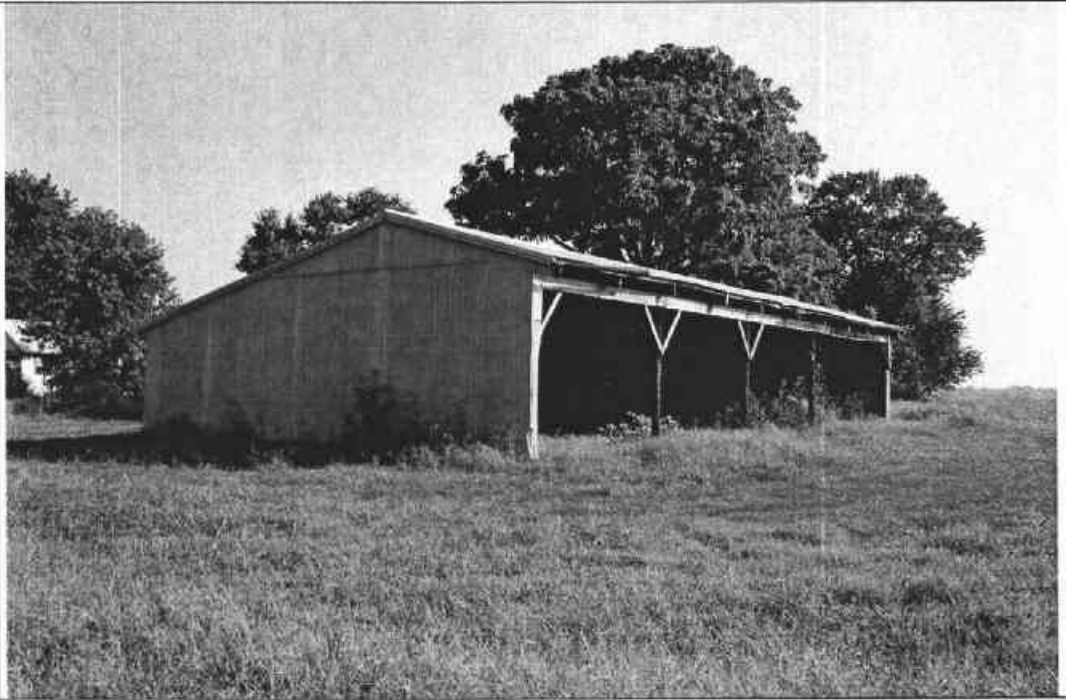
N05218. Photograph 3: Equipment shed, view looking southwest. This photo shows the original equipment shed located to the south of the farm complex.

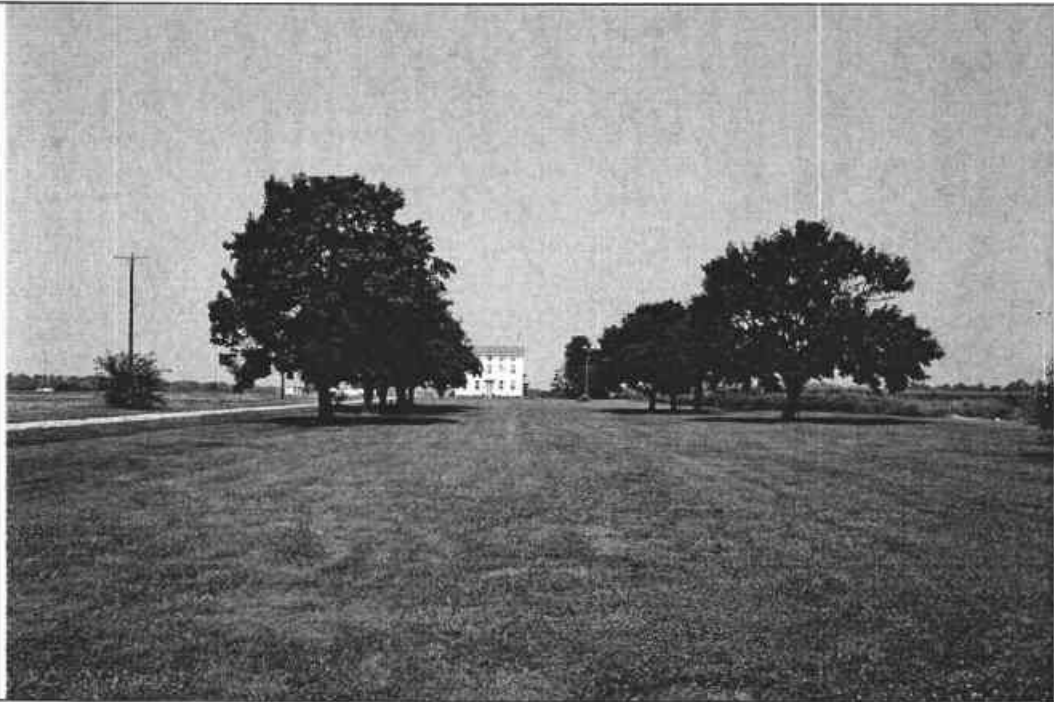
N05221. Photograph 1: Overview, view looking northwest. Note the remnants of the allee of trees that follow along the driveway. Modern trailers are just visible in the background.

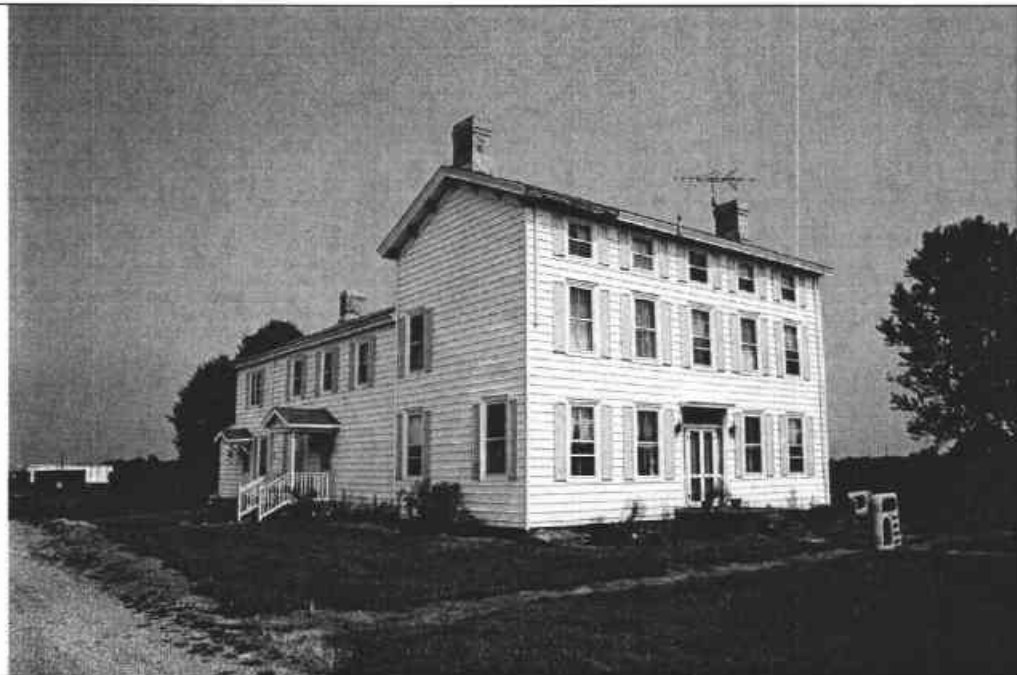
N05221. Photograph 2: Dwelling, south and east elevations, view looking northwest. Note the original two-over-two windows and brackets at the eaves.

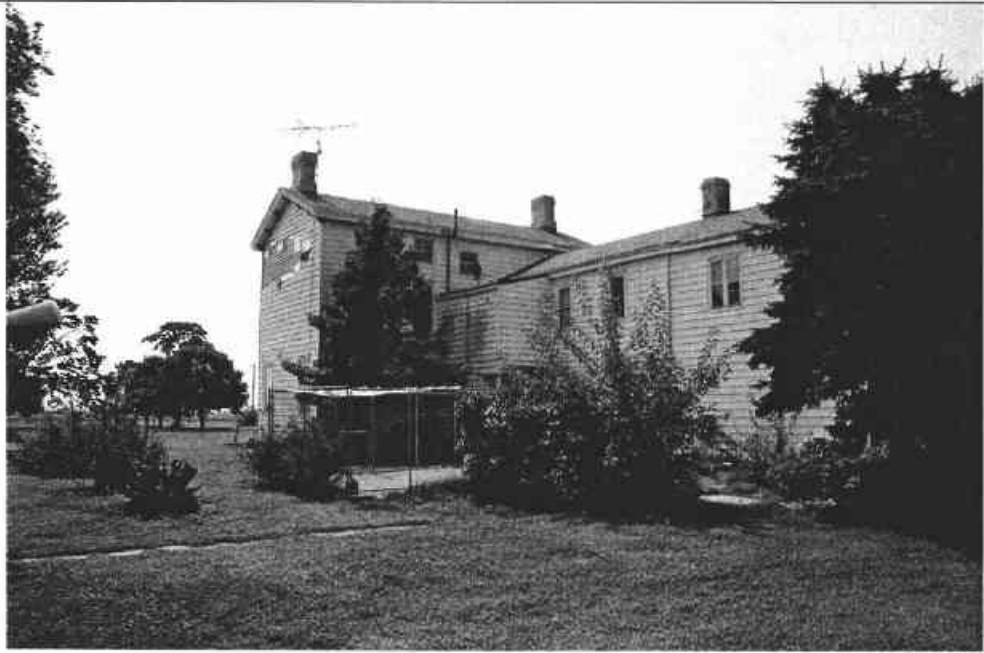
N05221. Photograph 3: Dwelling, north and west elevations, looking southeast. Note the missing aluminum siding on the north elevation exposing the original wood cladding.

4. INTEGRITY: Aluminum siding in poor condition and starting to fall off. Modern addition to barn since previous survey.

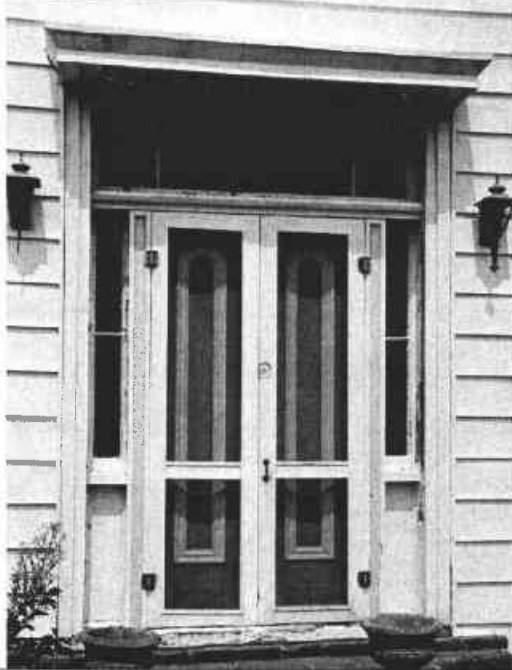
N05221. Photograph 4: View of main entrance to house on east elevation, looking west. Note sidelights, transom, and molded woodwork on door.

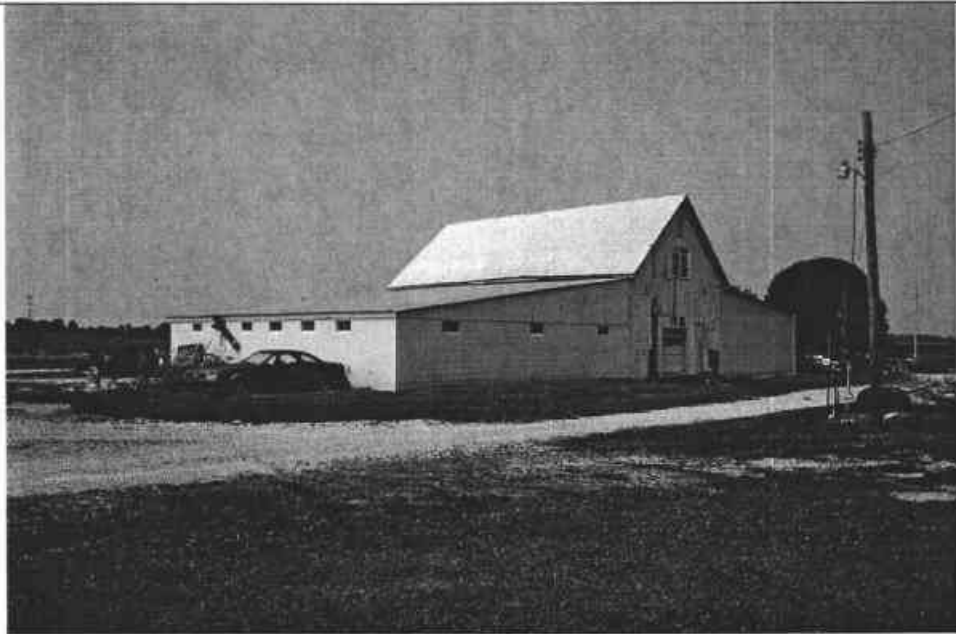
The barn is located to the west of the dwelling and features two flanking shed roof bays. The gable front frame structure is clad in vertical wood planks and rests on a stone foundation. The flanking shed roof bays were constructed ca. 1940 of concrete block and ca. 1985 of frame clad in standing seam metal. The barn has been altered through these additions as well as the addition

N05221. Photograph 5: Barn, east and north elevations, view looking southwest. Note the *circa*-1940 and *circa*-1985 additions. The barn is in poor condition and is the only extant outbuilding.

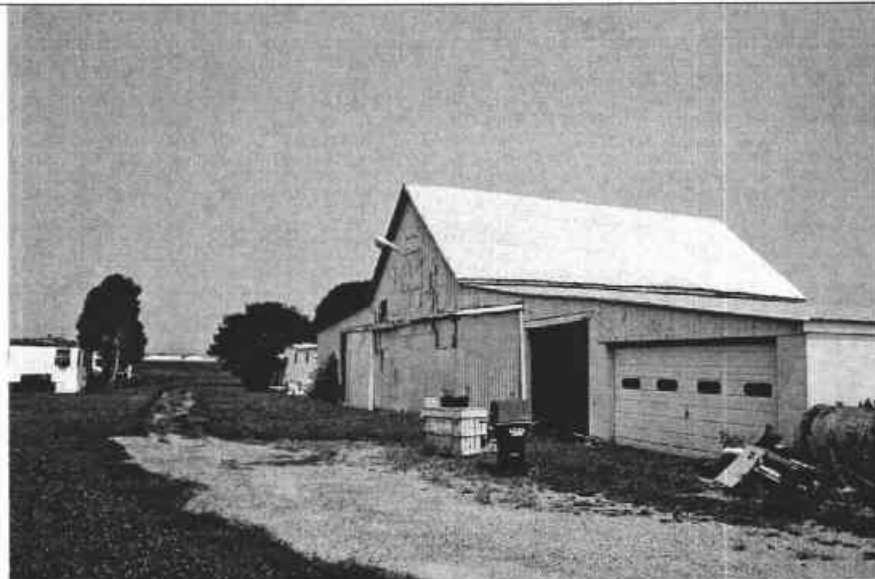
N05221. Photograph 6: Barn, south elevation, view looking northwest. Note the modern mobile home on the left hand side of the photograph.

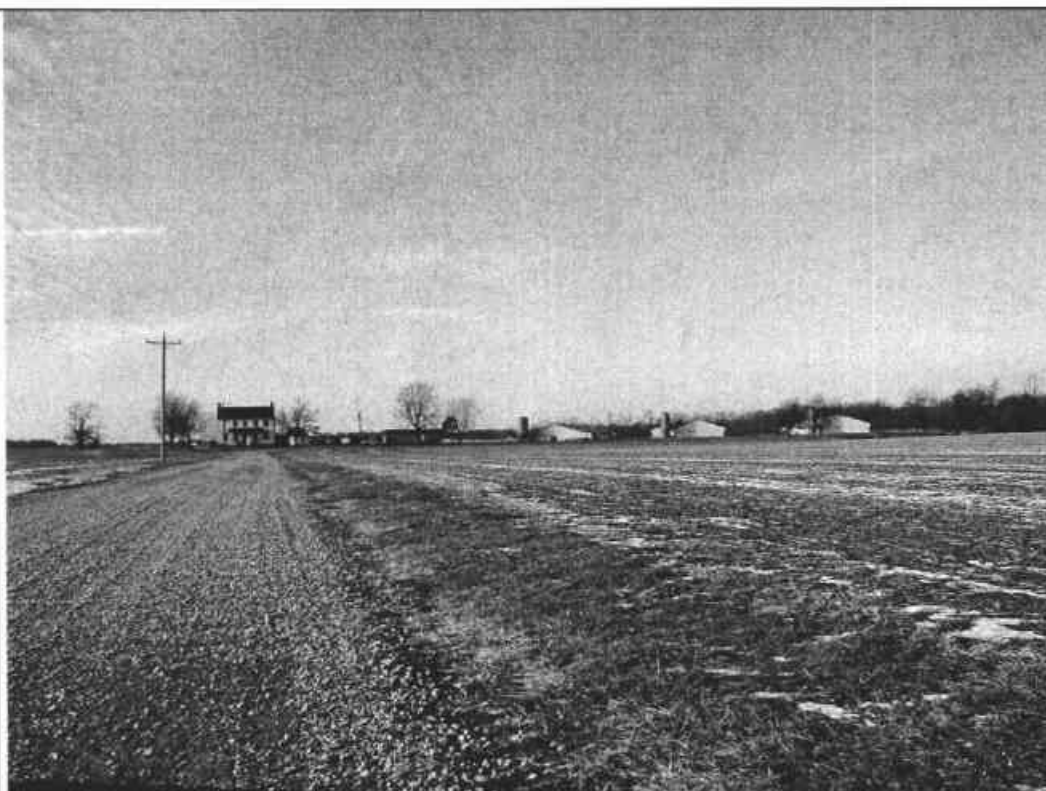
N05223. Photograph 1: Samuel Price Farm, overview, view looking northwest. Note modern poultry houses to right.

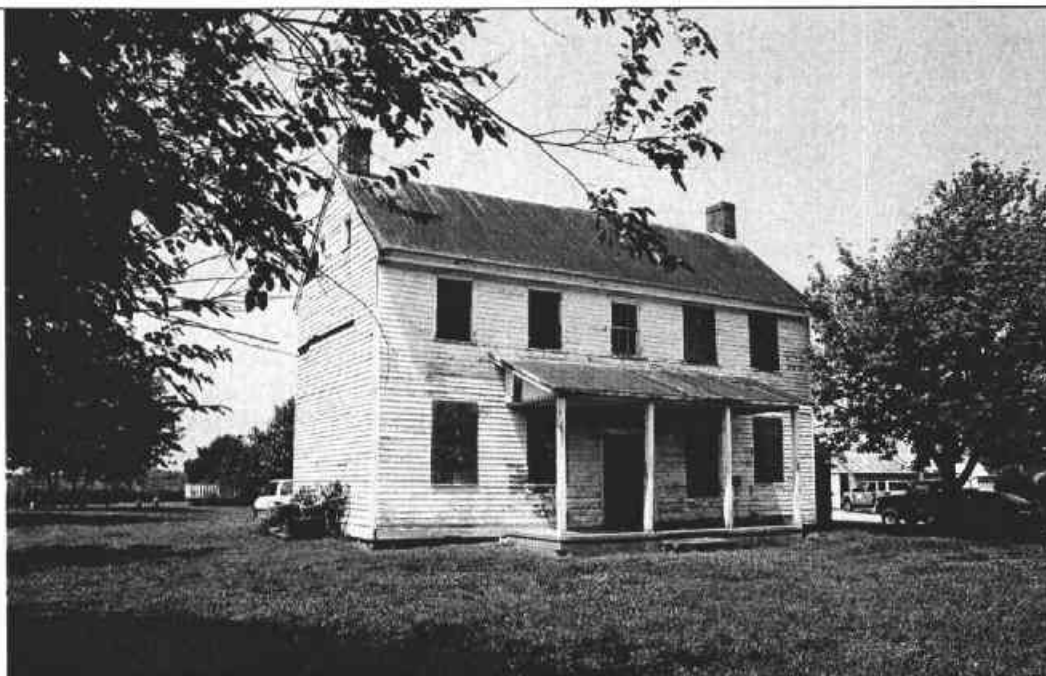
N05223. Photograph 2: Dwelling, west and south elevations, view looking northeast. Note that the windows have been partially removed or boarded over and that the vacant dwelling is in poor condition.

4. INTEGRITY: House abandoned and in poor condition. Barn, silo, corncrib and chicken coop identified in 1979 survey are no longer extant.

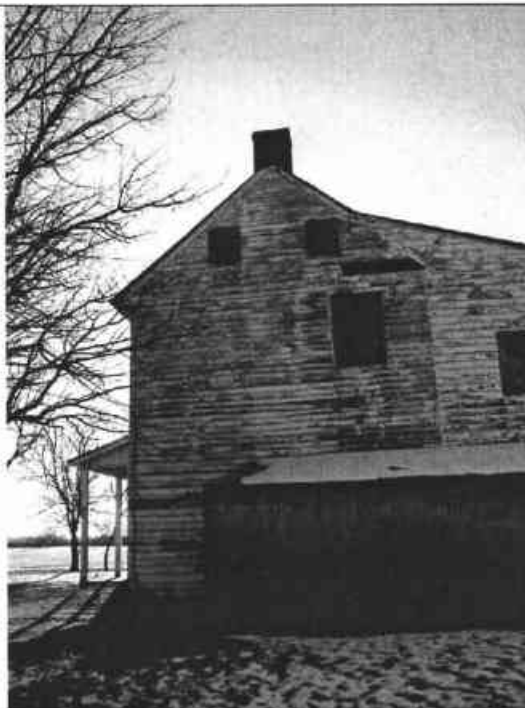
N05223. Photograph 3: Dwelling, east elevation, view looking west. Note *circa-1968* ell addition and *circa-1985* shed roof addition.

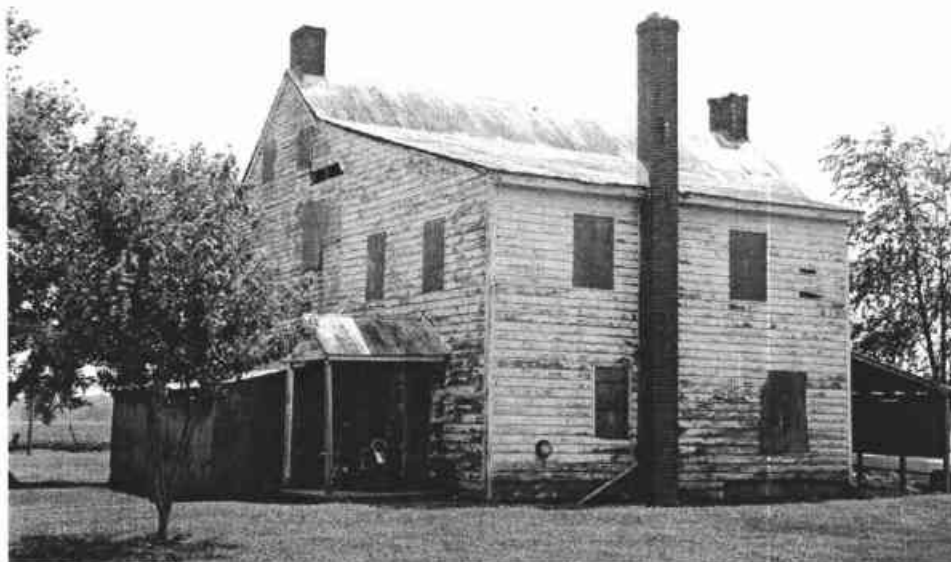
N05223. Photograph 4: Dwelling, east and north elevations, view looking south. Note *circa-1968* addition.

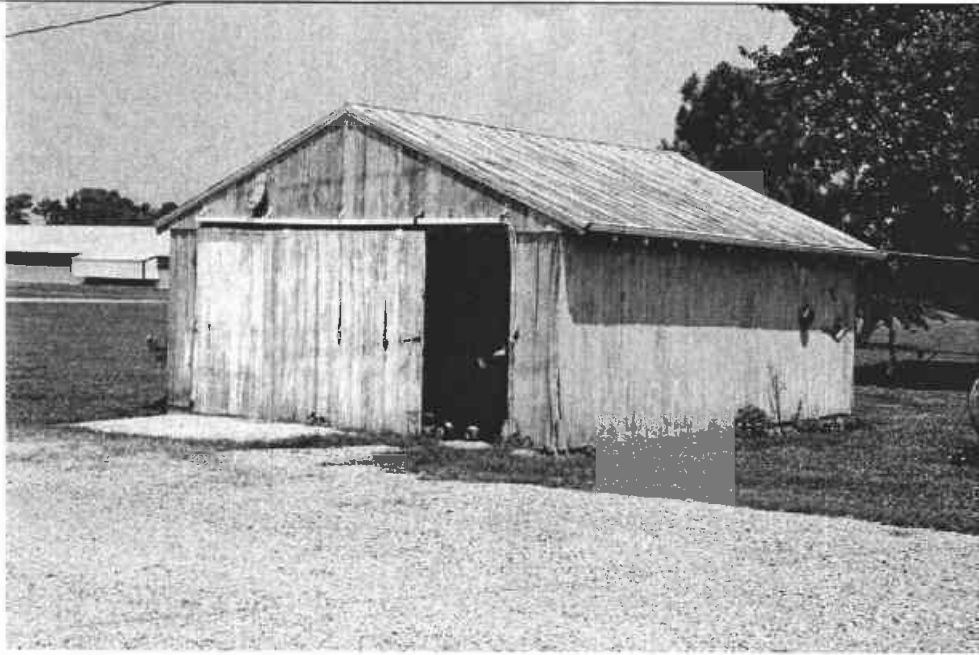
N05223. Photograph 5: Garage, west and south elevations, view looking northwest. Note the standing seam metal roof and sliding batten door.

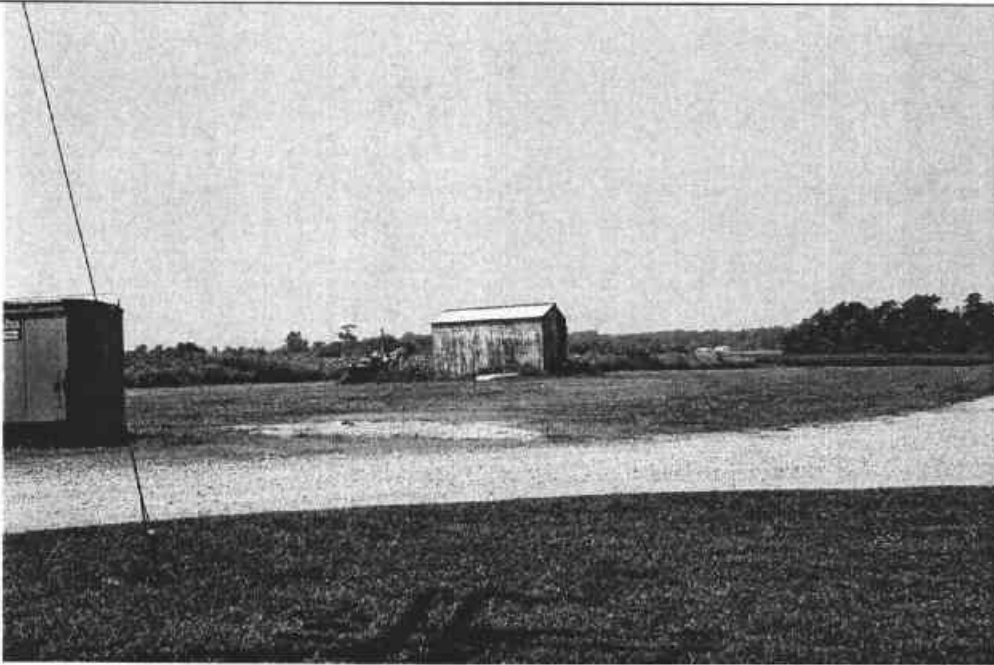
N05223. Photograph 6: Shed, south and east elevations, view looking north. This is the lone historic agricultural outbuilding remaining on the property.

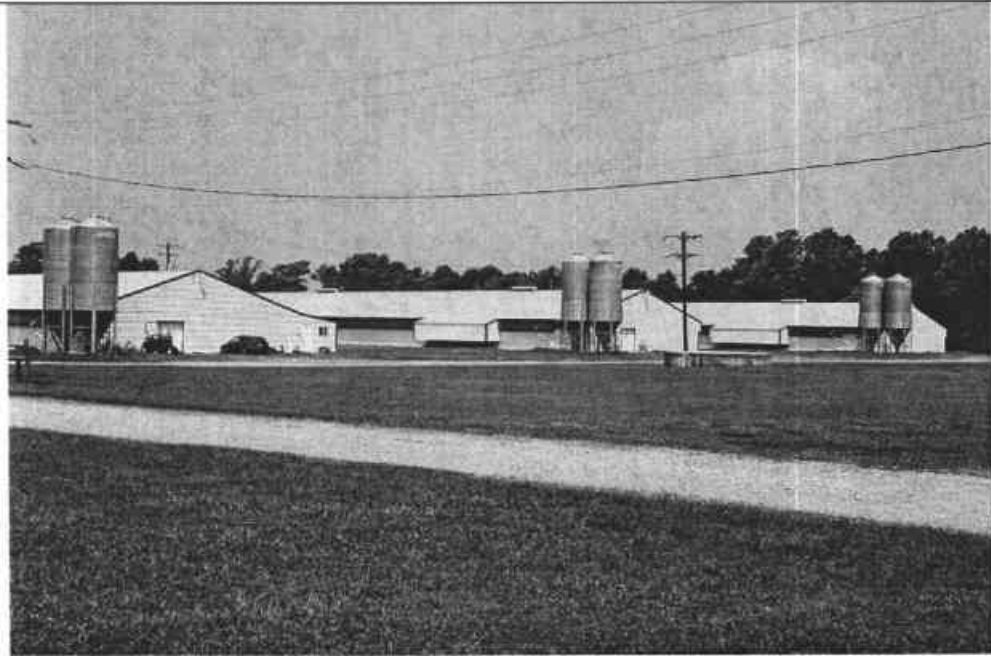
N05223. Photograph 7: Modern pole buildings, west and south elevations, view looking north. These buildings have replaced the historic agricultural outbuildings.

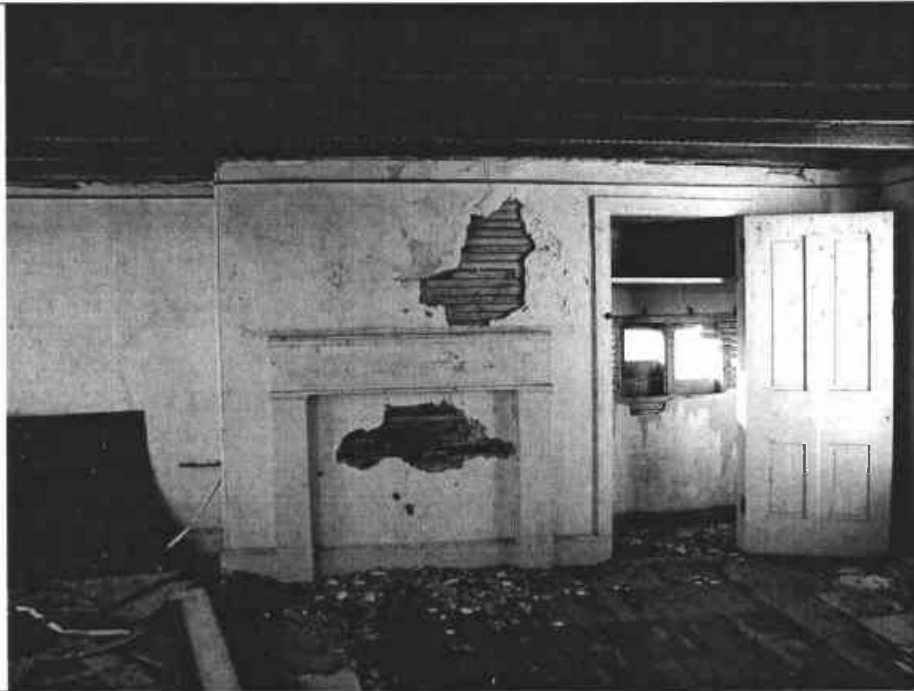
N05223. Photograph 8: Interior, second story, main block. Note the missing plaster above the mantle exposing the wood lath.

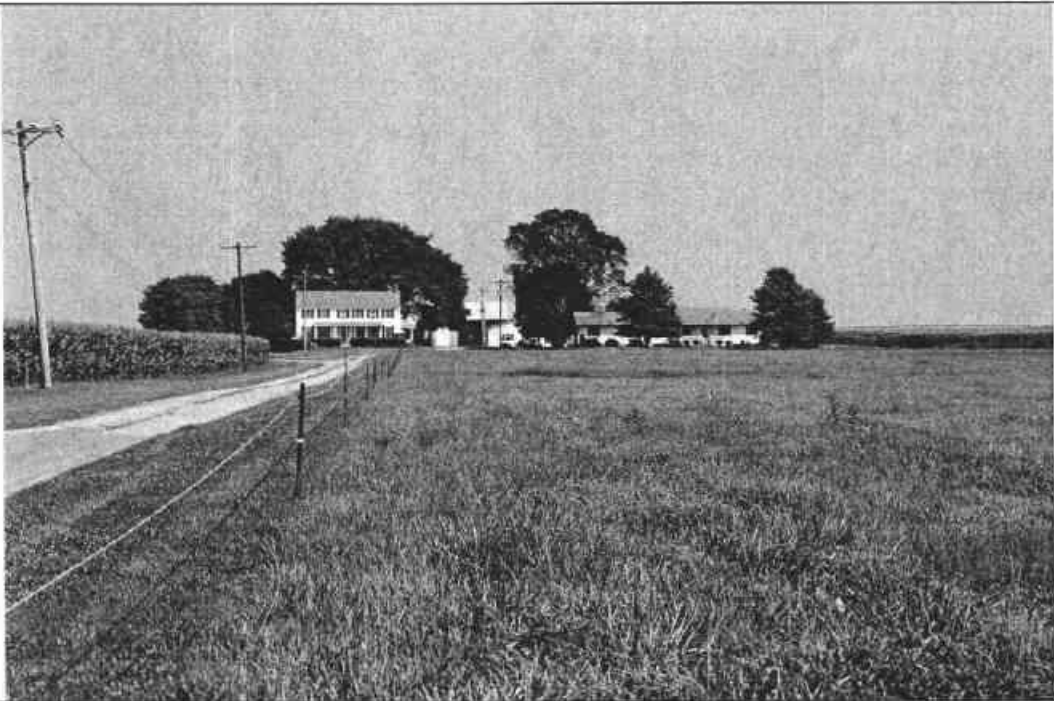
N05224. Photograph 1: Overview of farm from Middletown Warwick Road, view looking east.

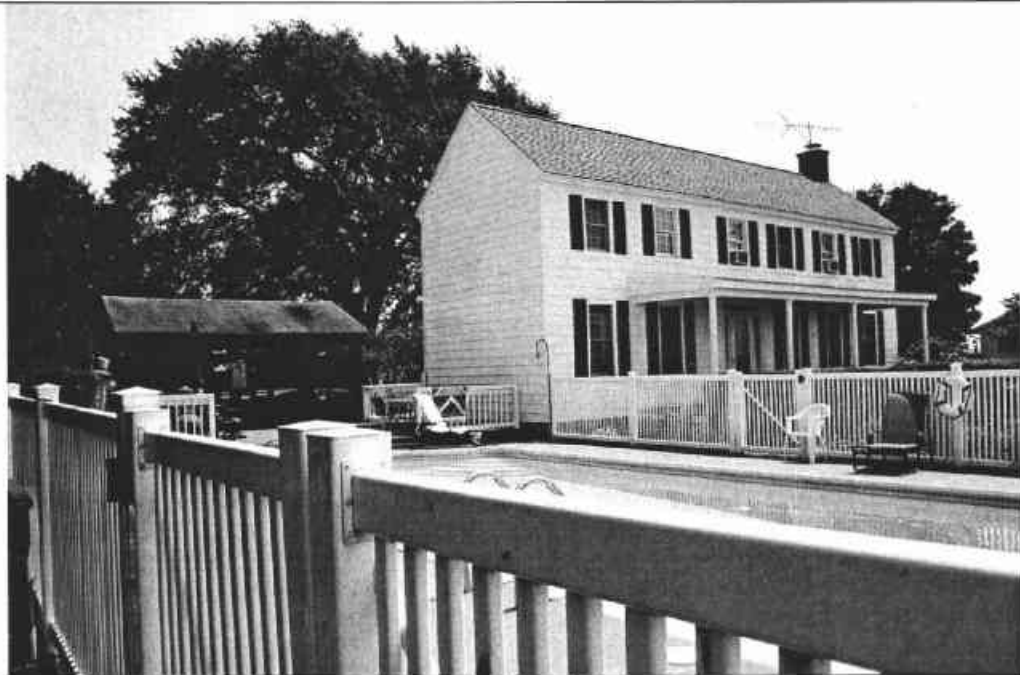
N05224. Photograph 2: Dwelling, north and west elevations, view looking southeast. Note pool in foreground and pool house to the rear.

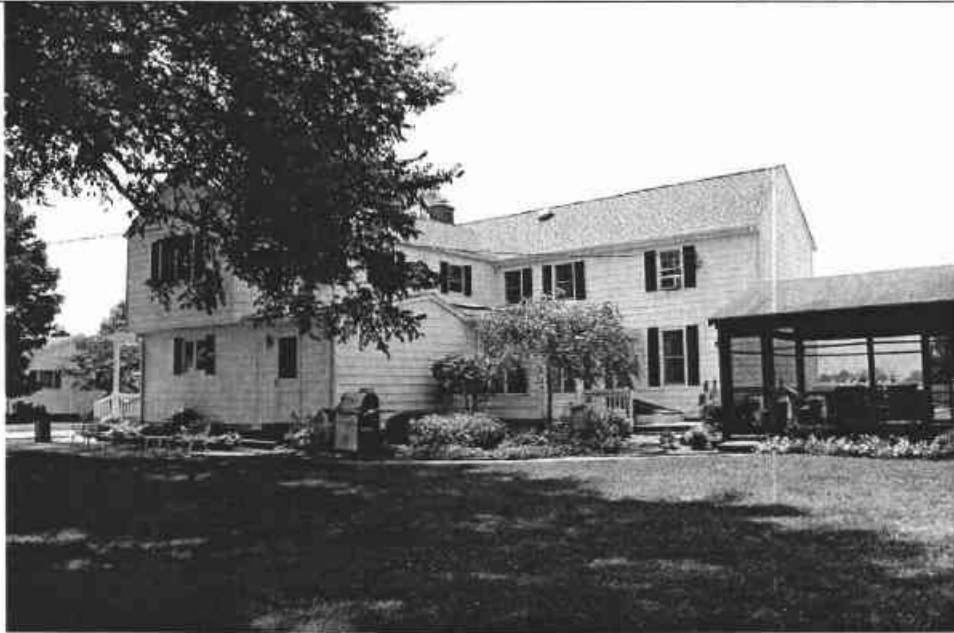
N05224. Photograph 3: Dwelling, east and north elevations, view looking southwest.
